# Morphological Analysis of Apical Foramen Over-instrumented by Three Rotary NiTi Systems

**Objective:** To evaluate morphological changes of the apical surface after root canal preparation with 1 mm beyond the apical foramen using ProTaper Universal (PTU) files, K3 files and Twisted files (TF), respectively.

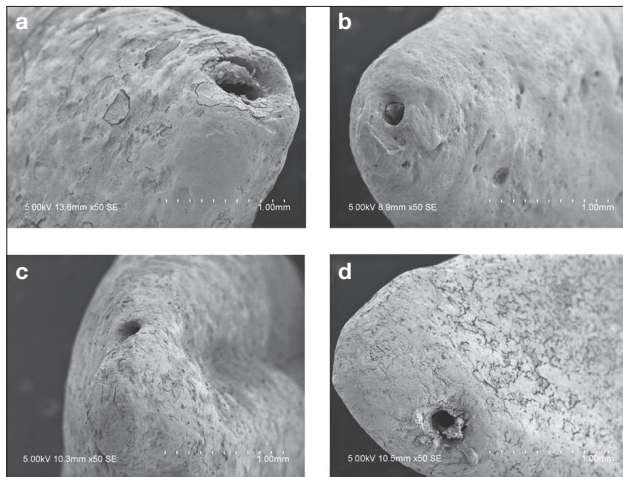
**Fig 1** Foramen-centred and foramen-deviated group. Major foramen in the center of their root tips (a, c); foramen-deviated group with deviations of the major foramen >0.5 mm from the root apex (b, d).

Extracted human maxillary central incisors were selected after examination under stereomicroscopy (XT-III, Jiangxi KongFungYi Technology Company) under 20 × magnification to exclude any cases with preexisting craze lines and cracks. In order to eliminate the influence of curvature factor on experiment results, the curvatures of the teeth between 0° and 8° were included. When the distance from the centre of their root tips to the major apical foramina was above 0.5 mm, it was regarded as a foramen-deviated tooth, otherwise, it was regarded as a foramen-centred tooth. Seventy foramen-centred and 70 foramen-deviated teeth were included as Group A and Group B, respectively. In each group, 20 teeth were randomly assigned for preparations with PTU files (Dentsply Maillefer, Ballaigues, Switzerland), K3 files (SybronEndo, Orange, CA) and TF files (SybronEndo, Orange, CA), respectively; the remaining 10 teeth were used as the control group without any

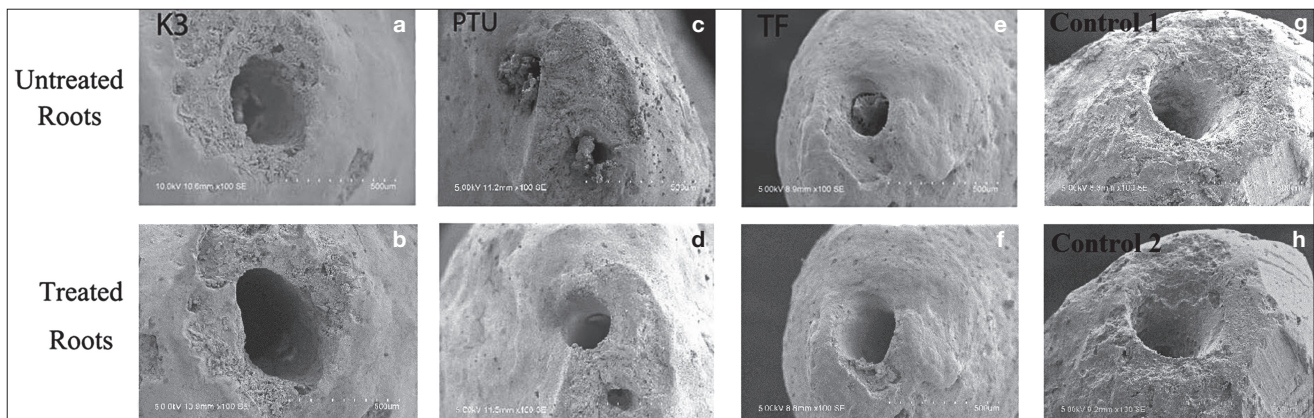
**Fig 2** SEM of the apical foramen morphology before (a,c,e,g) and after (b,d,f,h) preparation with K3, PTU, TF files.

then prepared for SEM imaging similarly after instrumentation. Three pre- and postinstrumentation images for each sample centred on the apical foramen with different angles were taken.

The integrity damage of the apical foramens and the presence of dentin defects were defined by comparing the baseline image of each root with the postinstrumentation images of the same root. Foramen integrity damage (FID) was evaluated and determined when more than one-third circumference of the apical foramen was damaged by nickel-titanium rotary files or other external forces. Dentin defects (DDs) include any cracks, detachment and fracture of tooth structure around the apical foramen as described in previous studies<sup>12,13</sup>.

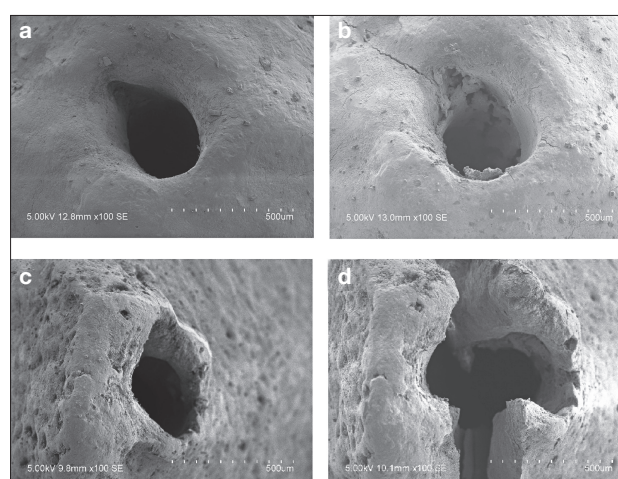
**Fig 3** Dentin defects in foramen-centred group (a, b) and in foramen-deviated group (c, d).

fracture susceptibility.<sup>14,15</sup> In the current study, even with a larger root, there were significant cracks (dentin defects) noted when the canals was overinstrumented, however it was highly significant when the foramen was deviated especially for the stiffer K3 files and to a slightly lower extent the larger tapered PTU files.
